REPORT NUMBER: 301-MGA-2009-008

**SAFETY COMPLIANCE TESTING FOR FMVSS 301R
FUEL SYSTEM INTEGRITY – REAR IMPACT**

**HYUNDAI MOTOR COMPANY
2009 HYUNDAI AZERA GLS
NHTSA NUMBER: C90507**

**PREPARED BY:
MGA RESEARCH CORPORATION
5000 WARREN ROAD
BURLINGTON, WI 53105**

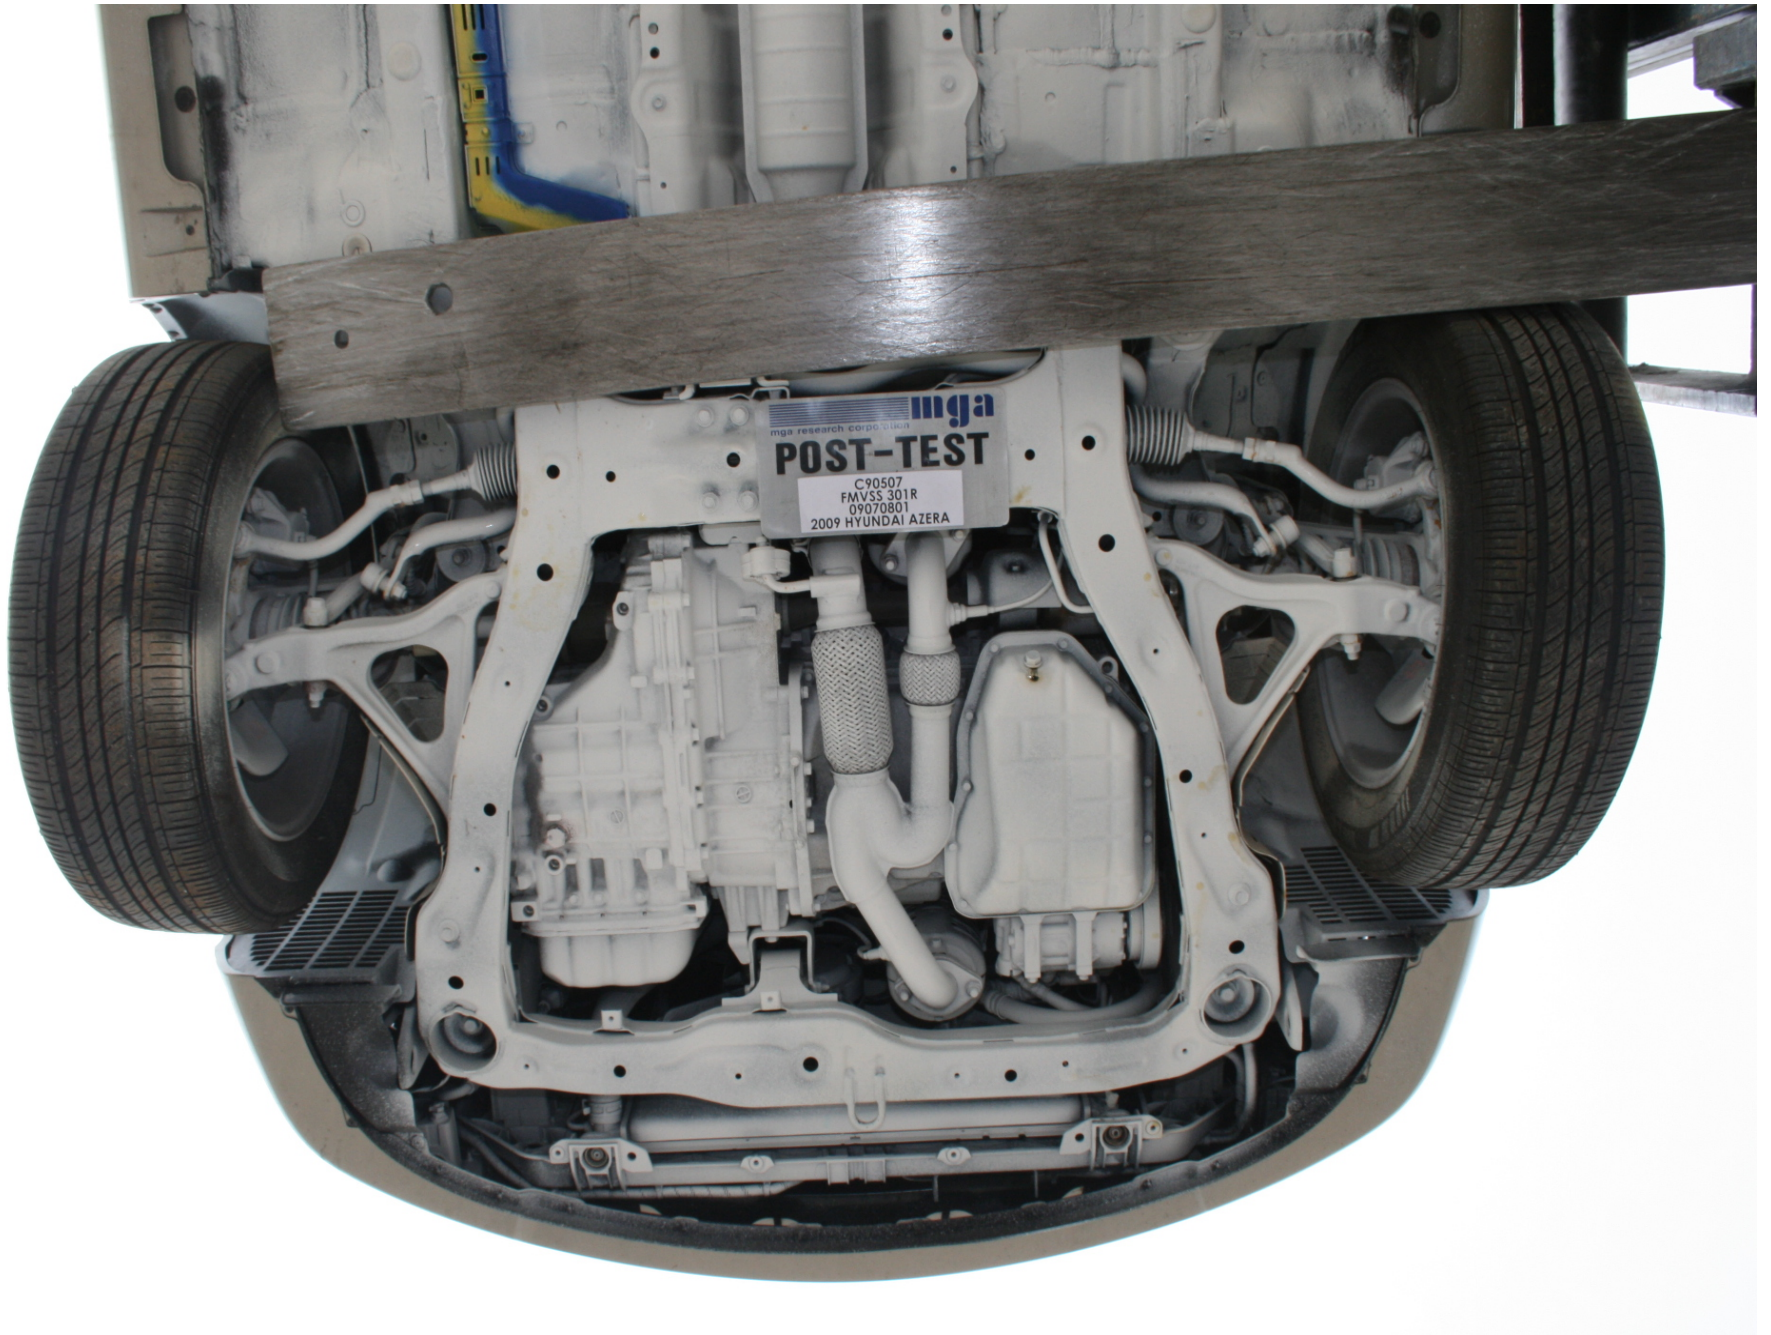
Post-Test Underbody View 1

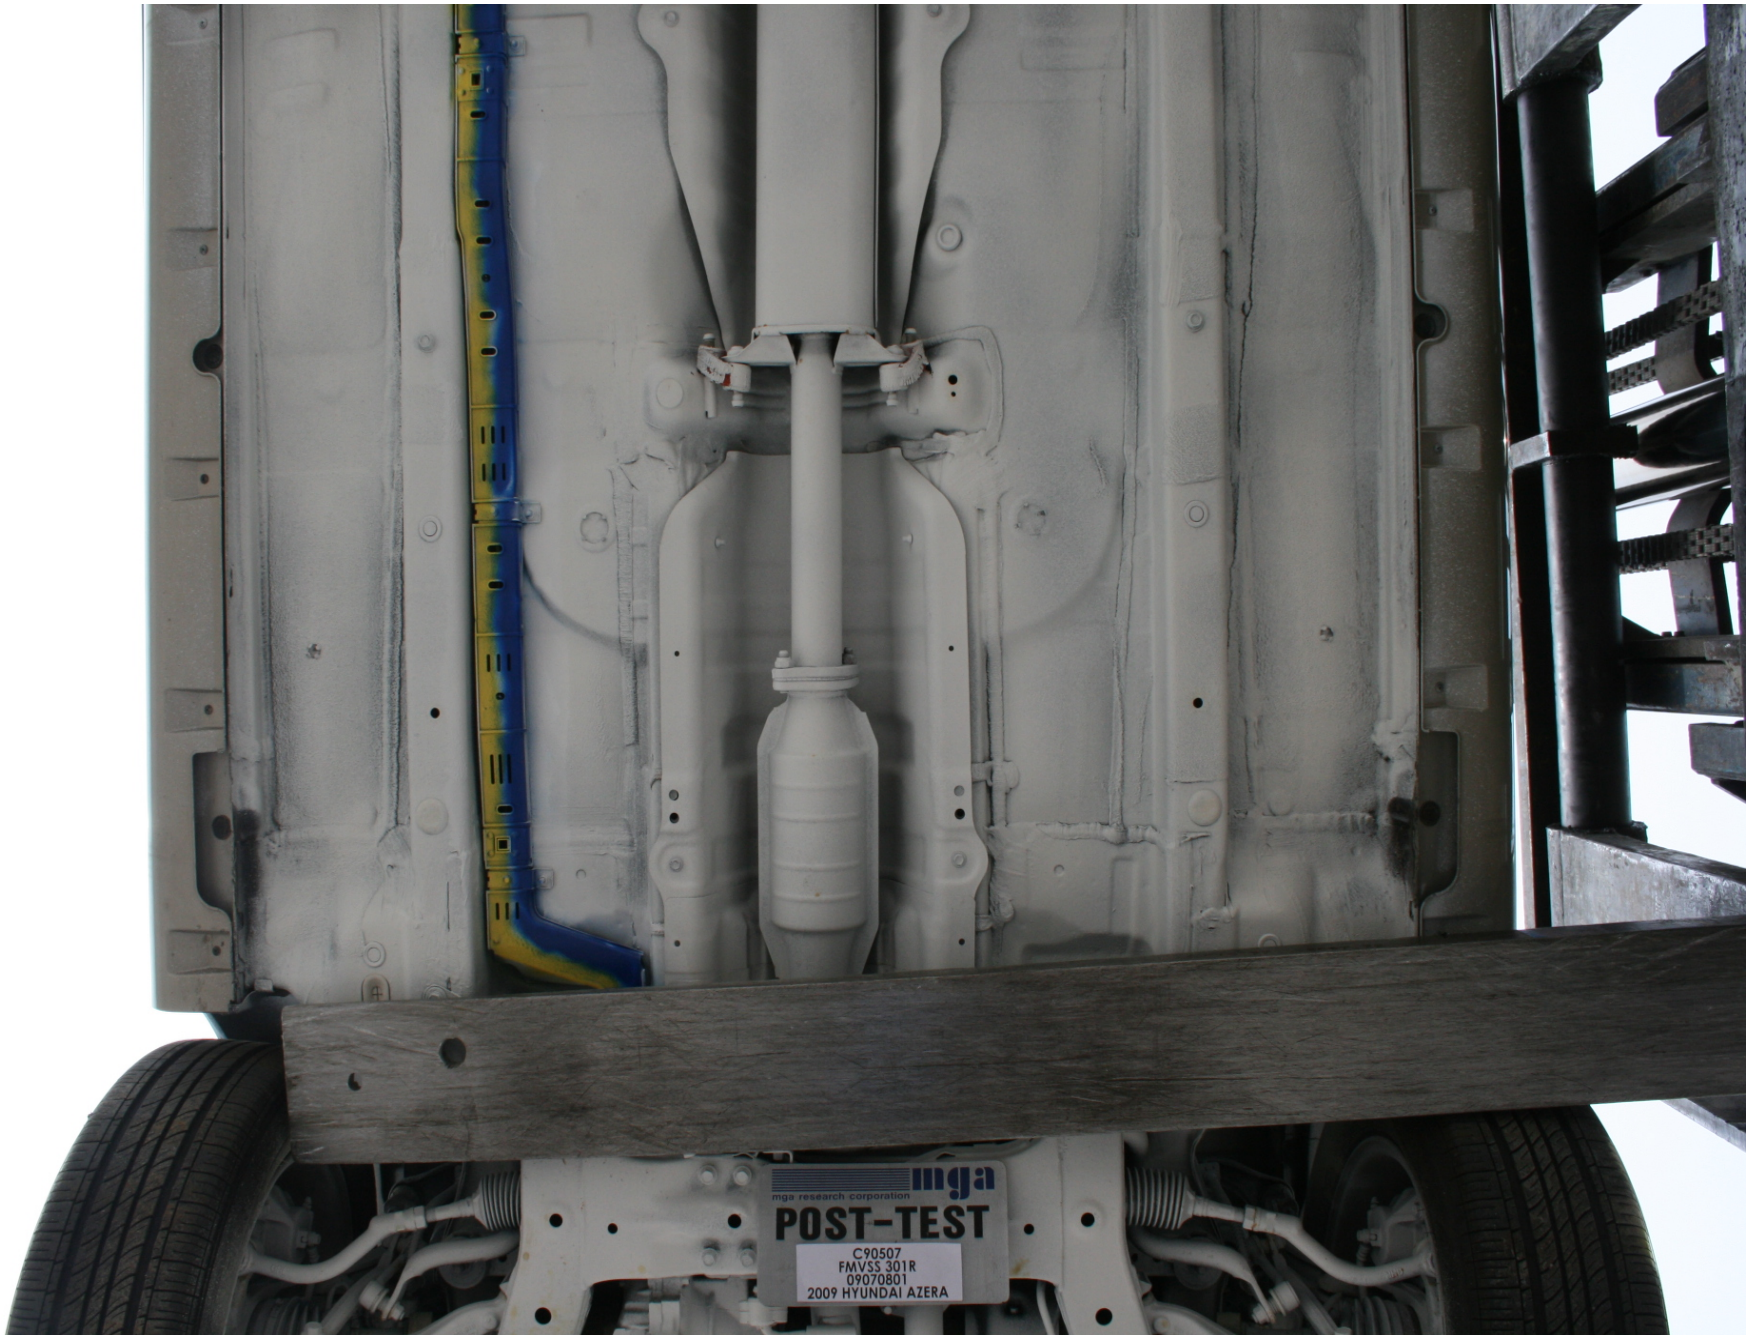
Post-Test Underbody View 2

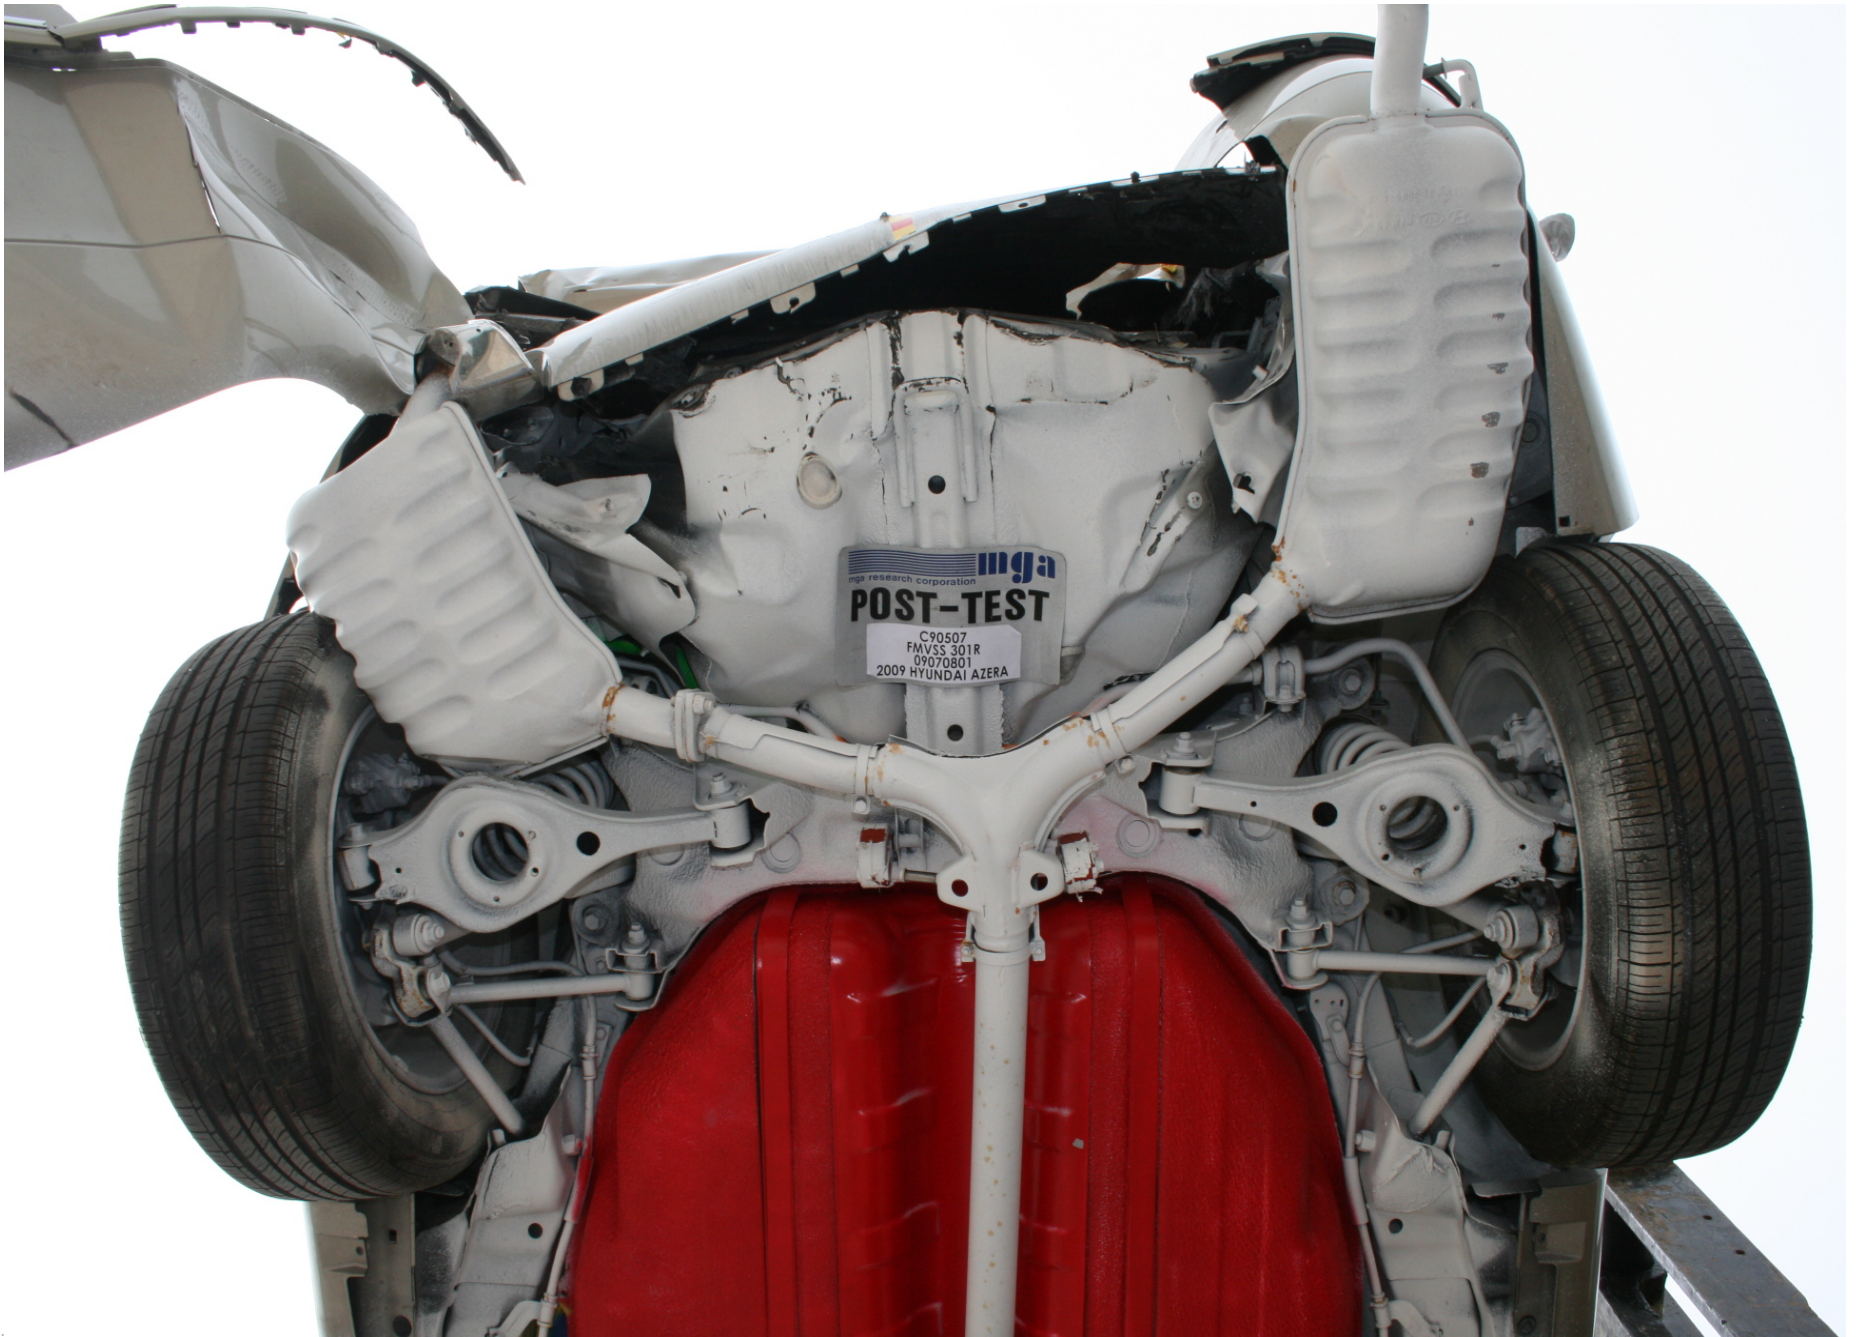
A-27.

Post-Test Underbody View 3

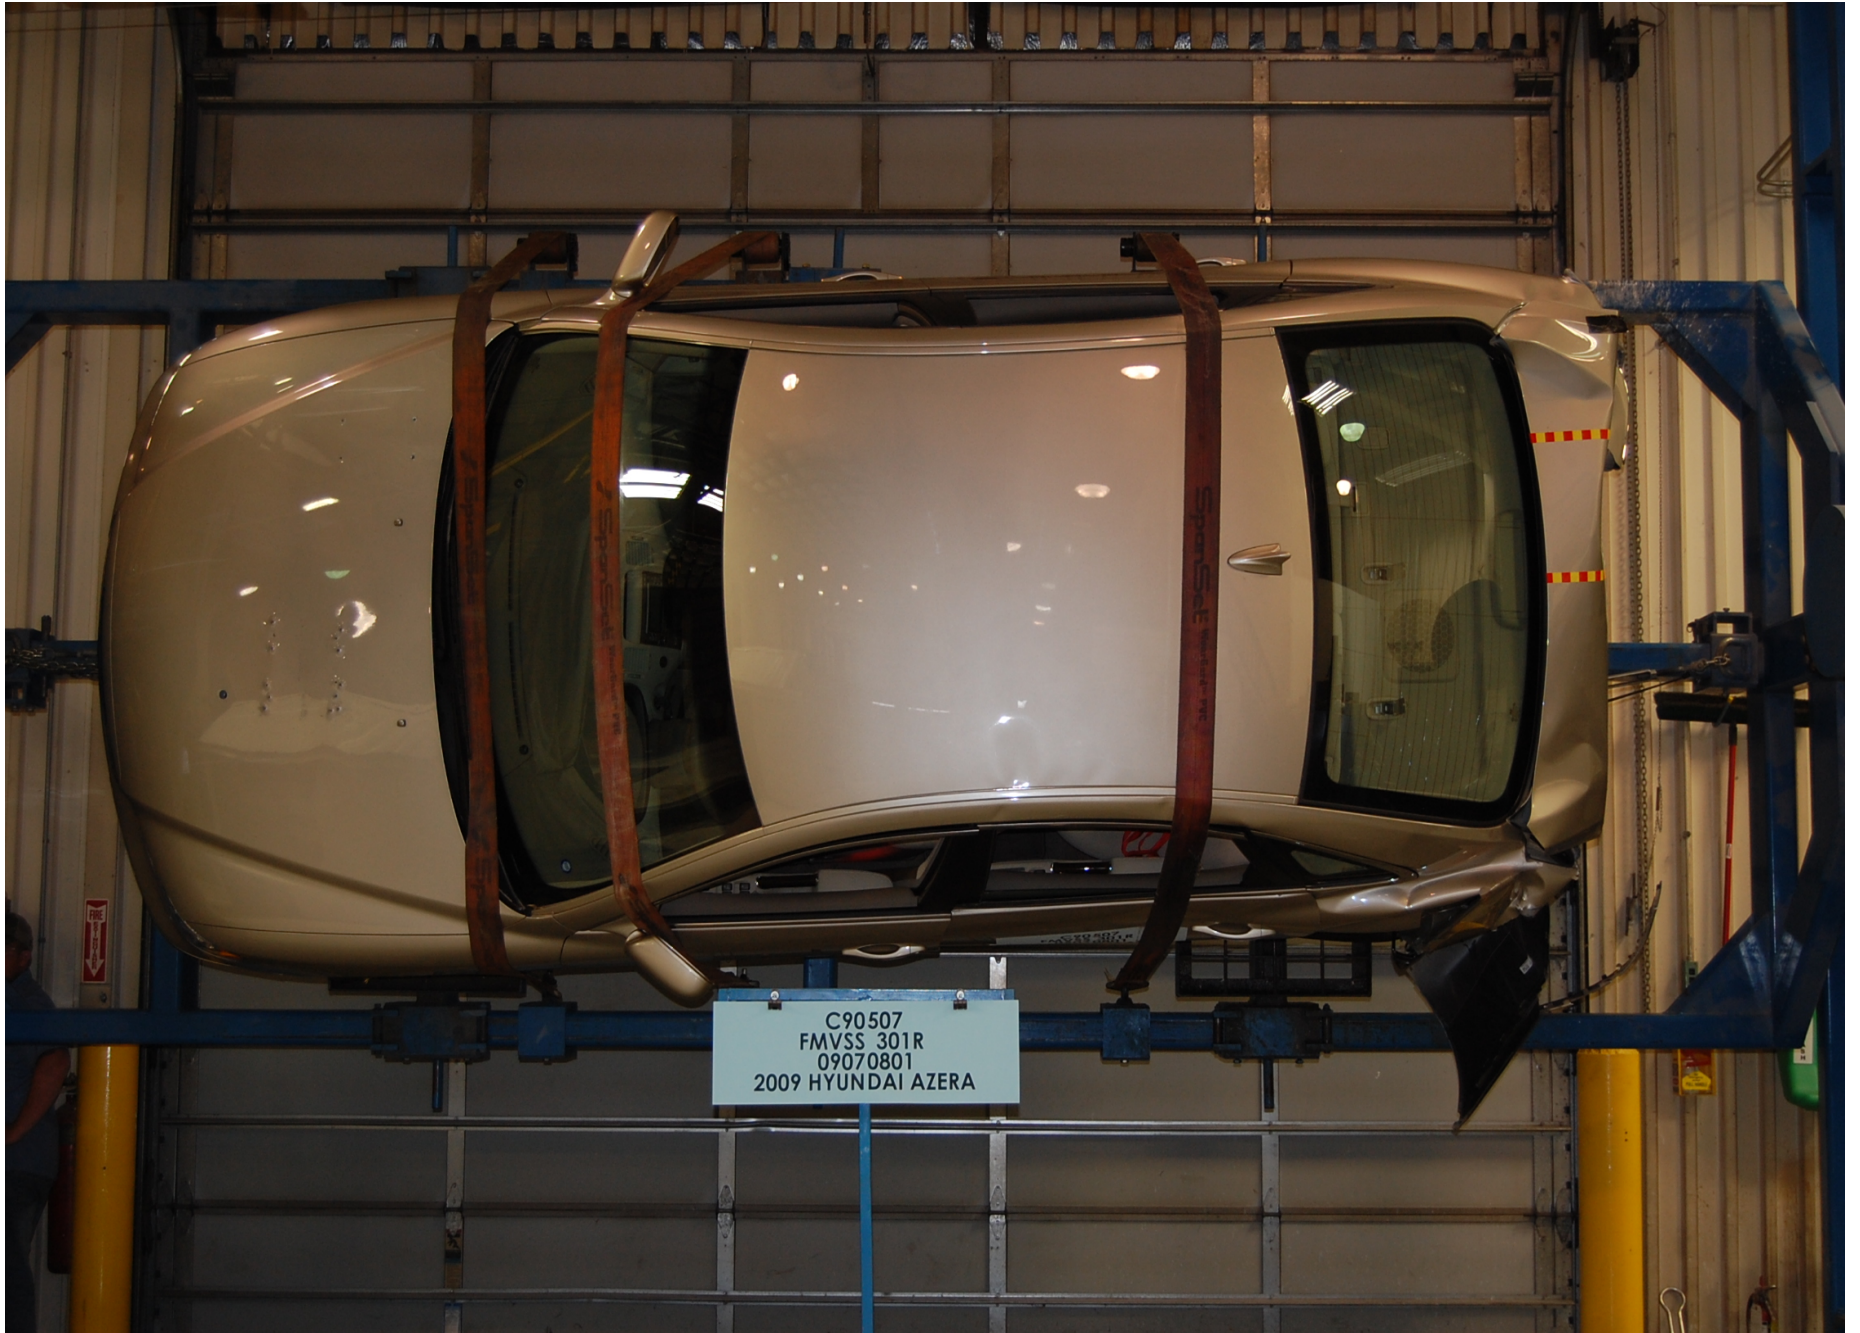
There was no Stoddard Solvent leakage after the event or during any phase of the static rollover.

Static Rollover at 90 Degrees

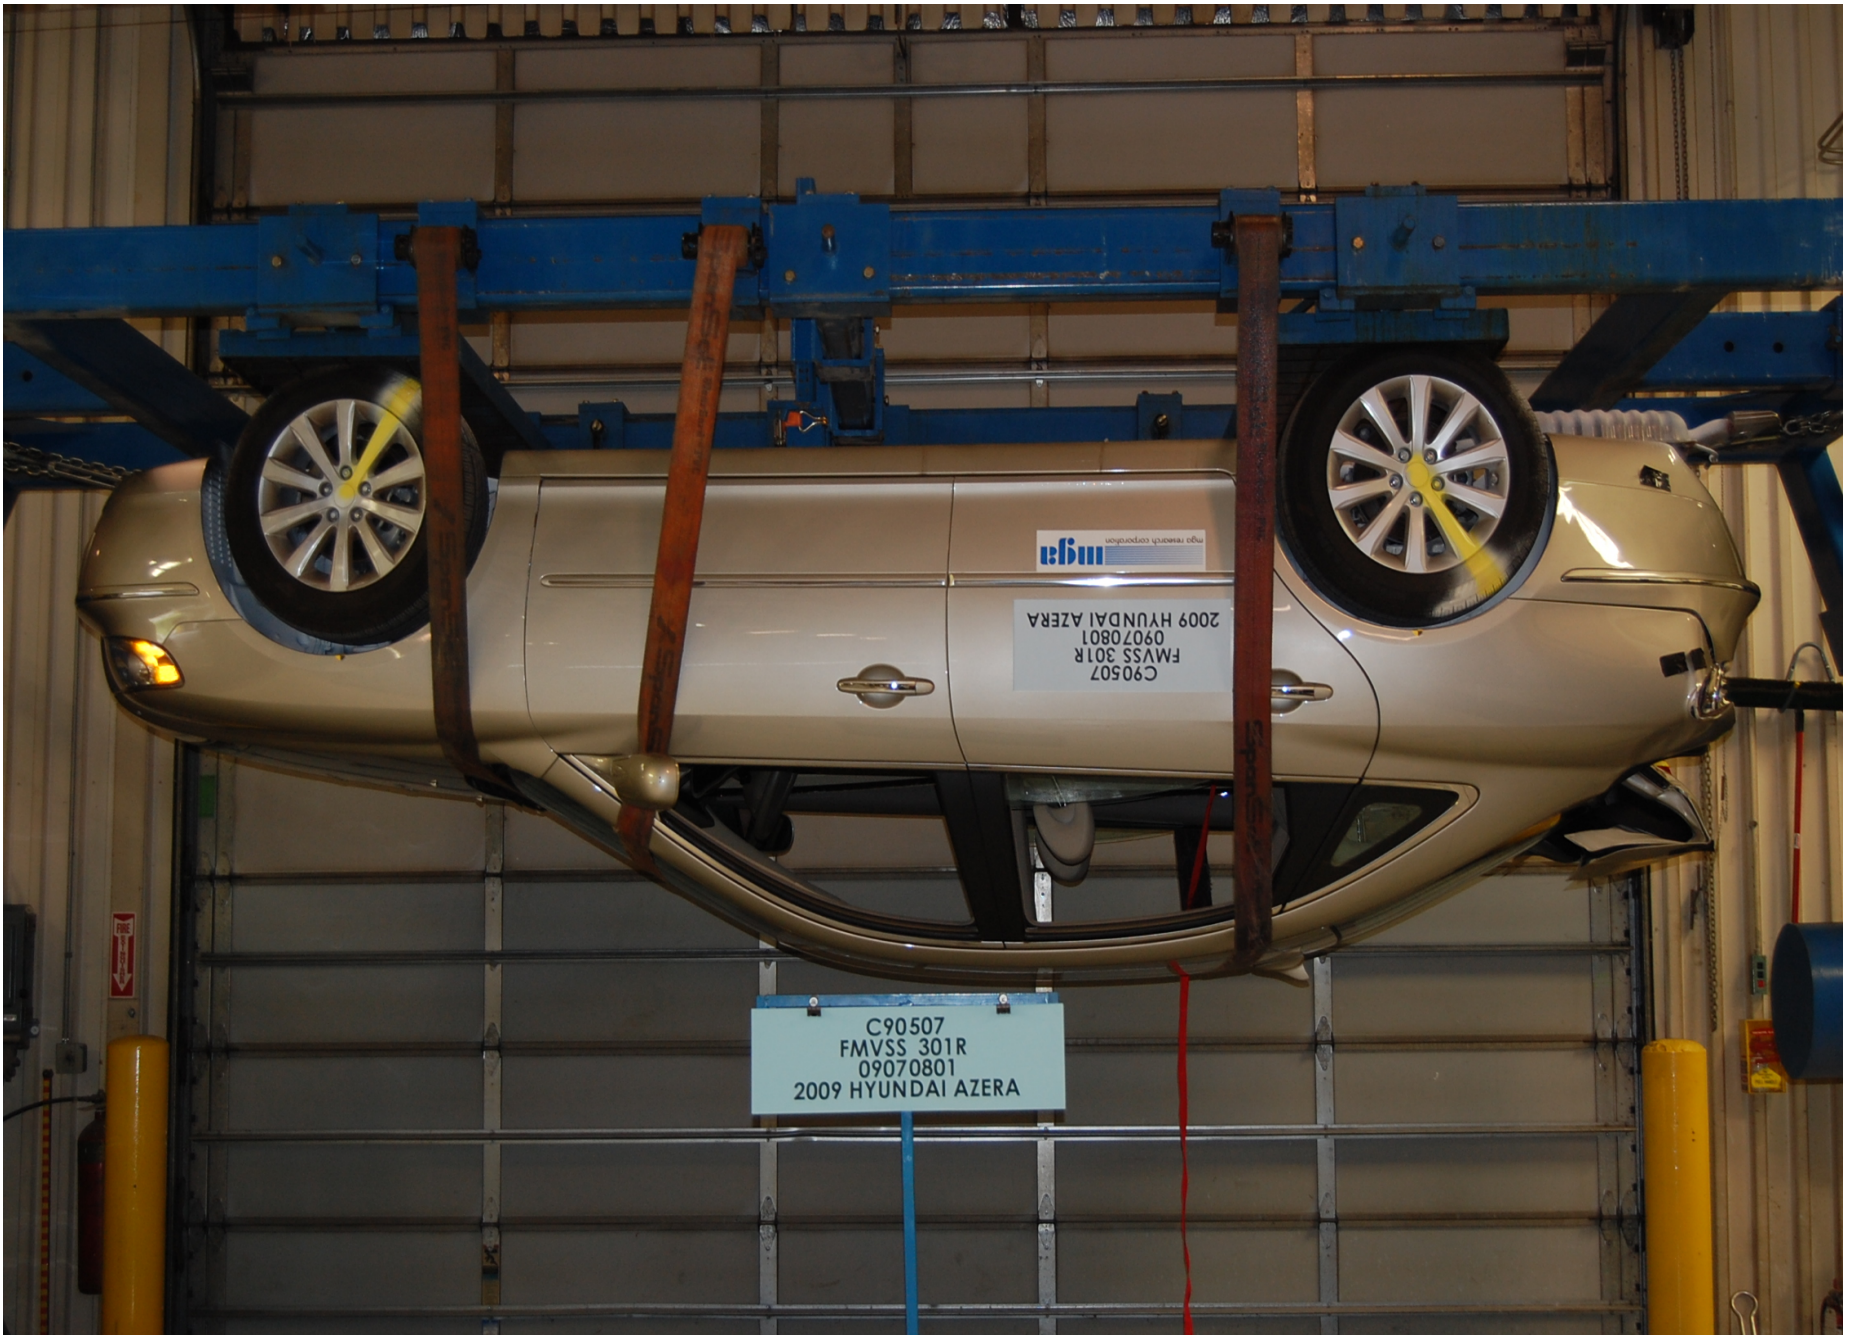
Static Rollover at 180 Degrees

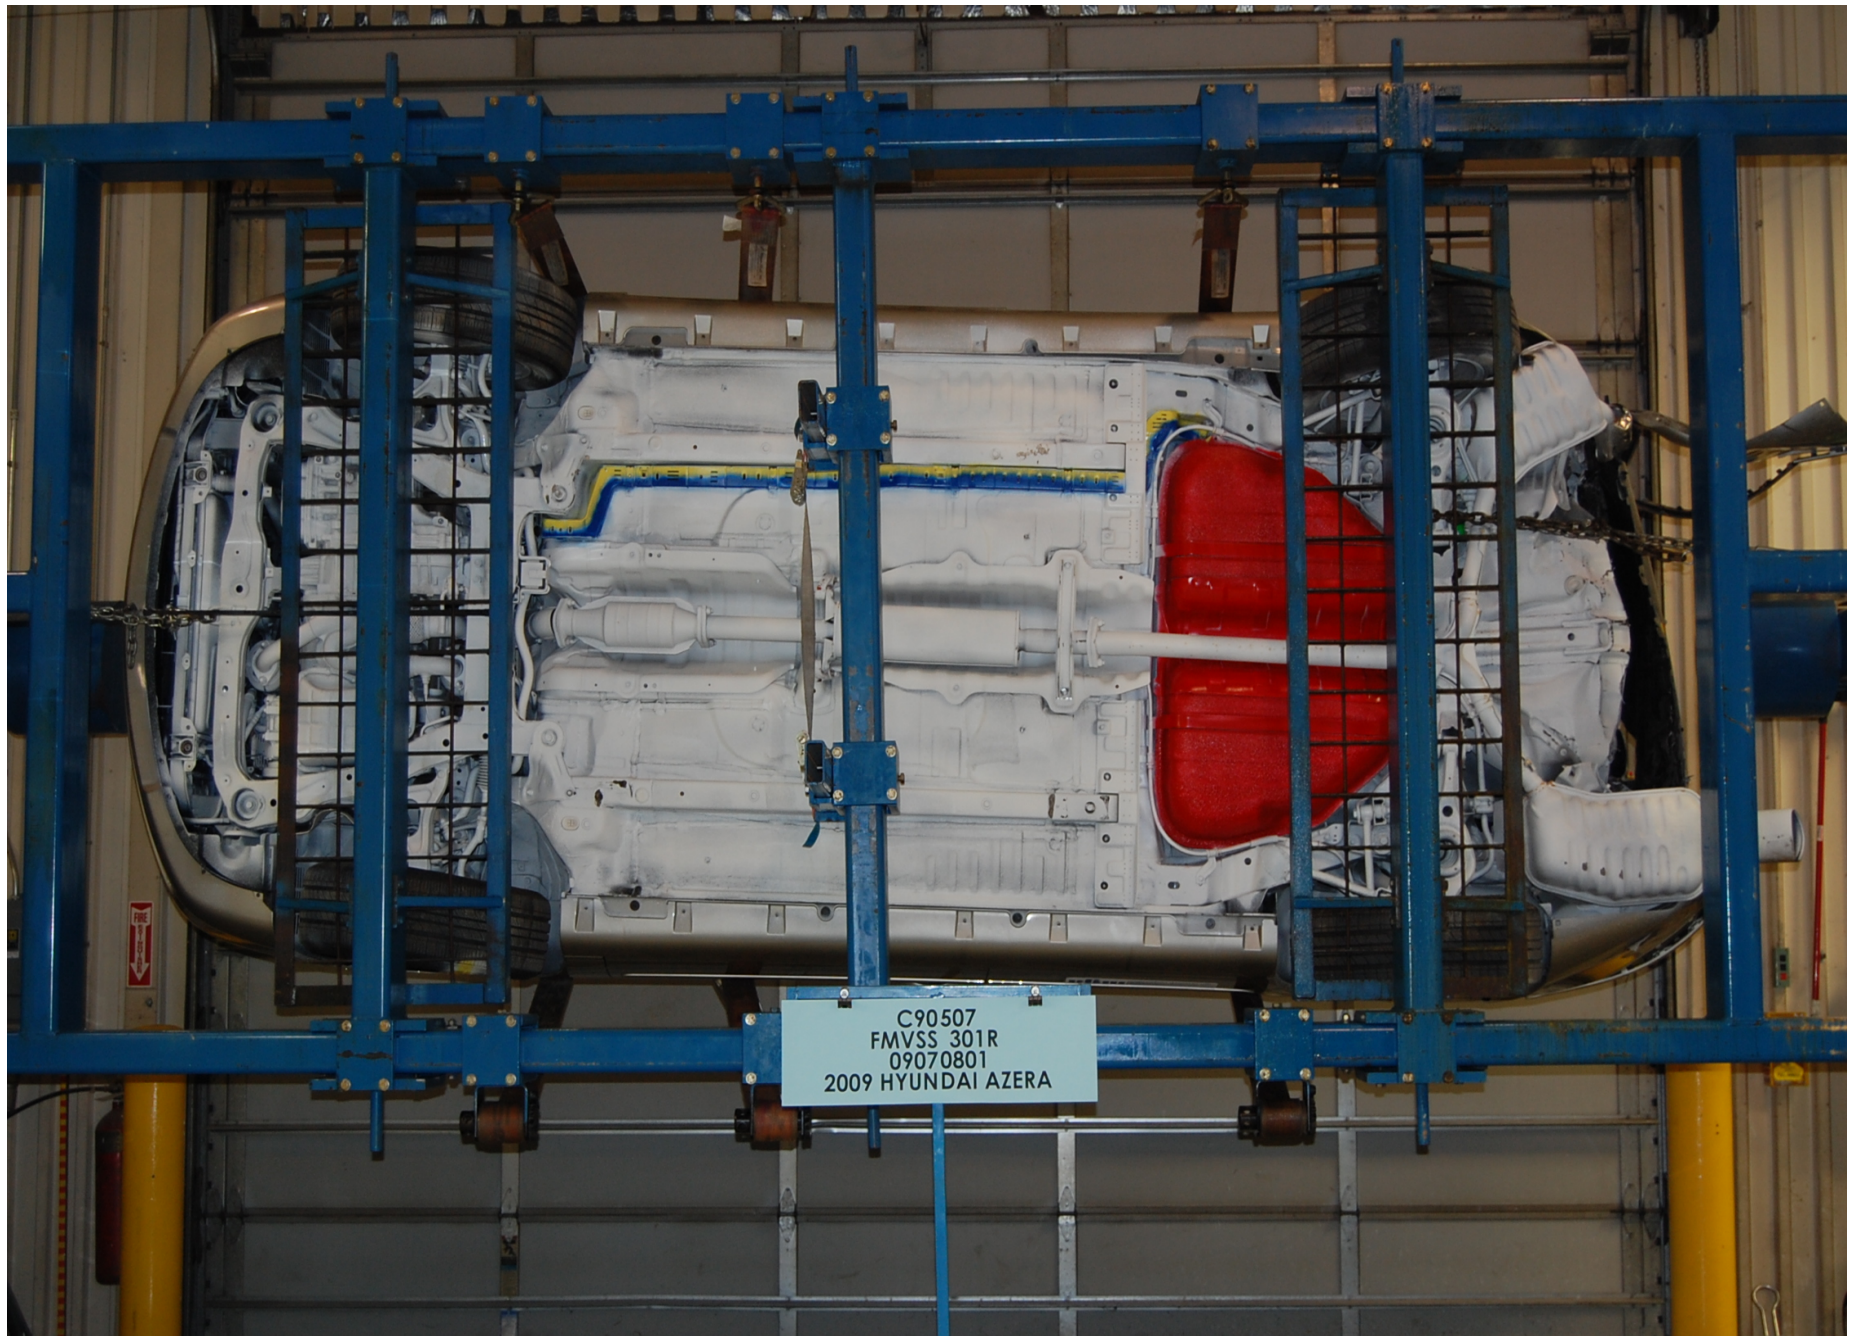
Static Rollover at 270 Degrees

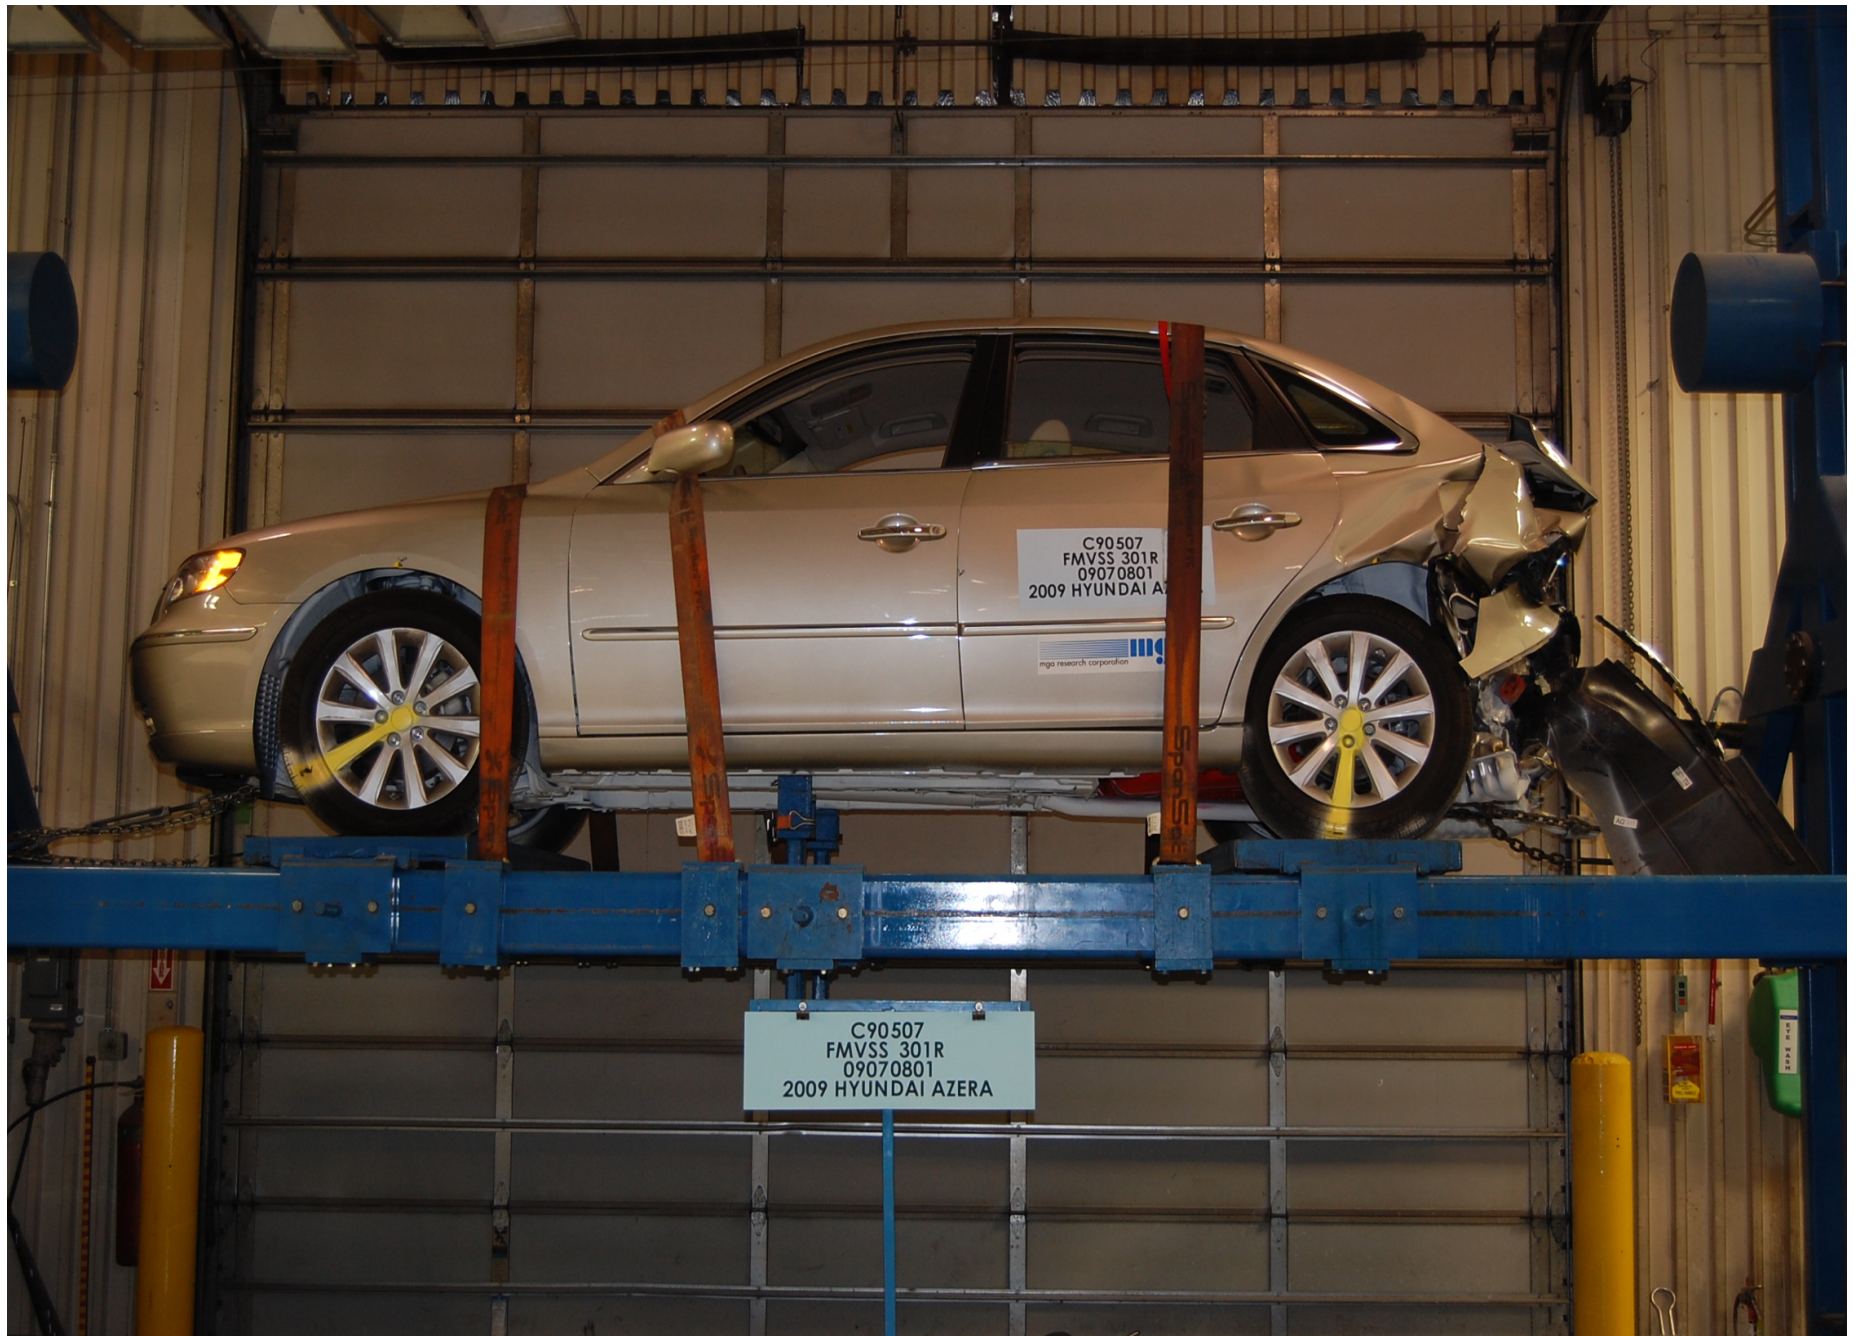
Static Rollover at 360 Degrees
